# Building Inspection Report

Prepared For: John and Linda Smith  
1234 Anystreet  
Maryland Heights, MO 63146

Report Number: 041281  
Inspection Date: 12/2/04 9:00 AM

Address: 3456 Anywhere Avenue, St. Louis MO 63139  
Sale Price: 158900  
Approximate Age: 70

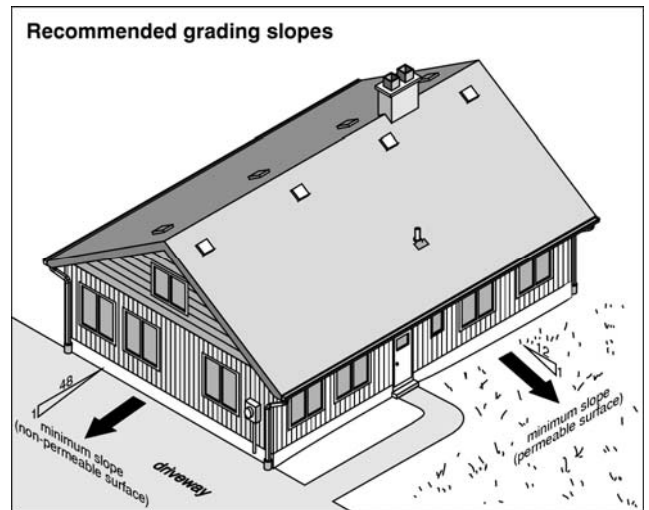
Proper grading is important to keep water away from the foundation. Soil should slope approximately 1 inch per foot in a direction away from the building for at least 6 feet to prevent problems caused by excess water. Excess water here can cause settlement of soil and lead to cracking of foundations and walls and water entry into the building. The water discharged from roof gutters and downspouts should be directed away from the foundation for the same reason.

This is a typical flat city lot. Maintaining drainage at sidewalks and downspouts is necessary to minimize basement seepage.
