Building Inspection Report

Property Information

Address: 1234 Anystreet, St. Louis MO 63116
Sale Price: 159999
Approximate Age: 78

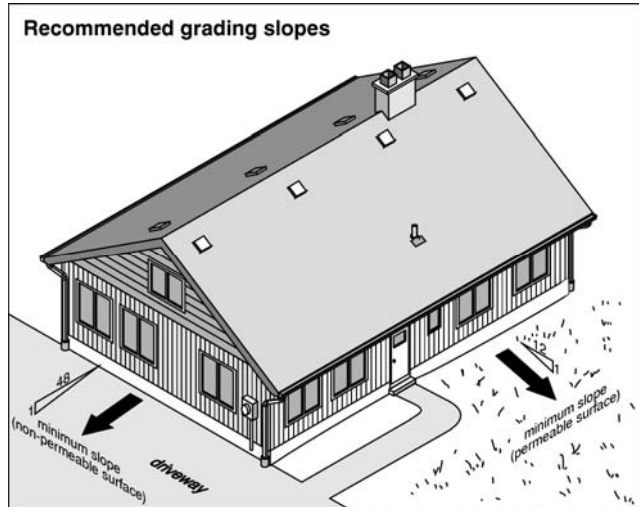
The lot is graded to slope toward the house in the rear.

Proper grading is important to keep water away from the foundation. Soil should slope approximately 1 inch per foot in a direction away from the building for at least 6 feet to prevent problems caused by excess water. Excess water here can cause settlement of soil and lead to cracking of foundations and walls and water entry into the building. The water discharged from roof gutters and downspouts should be directed away from the foundation for the same reason.
